Cobham SATCOM Global Technical Service dept.

Date: December 2014 Document Number: 95-144677-A

TT-3020C & TT-3022D GPS/Wrong time issue.

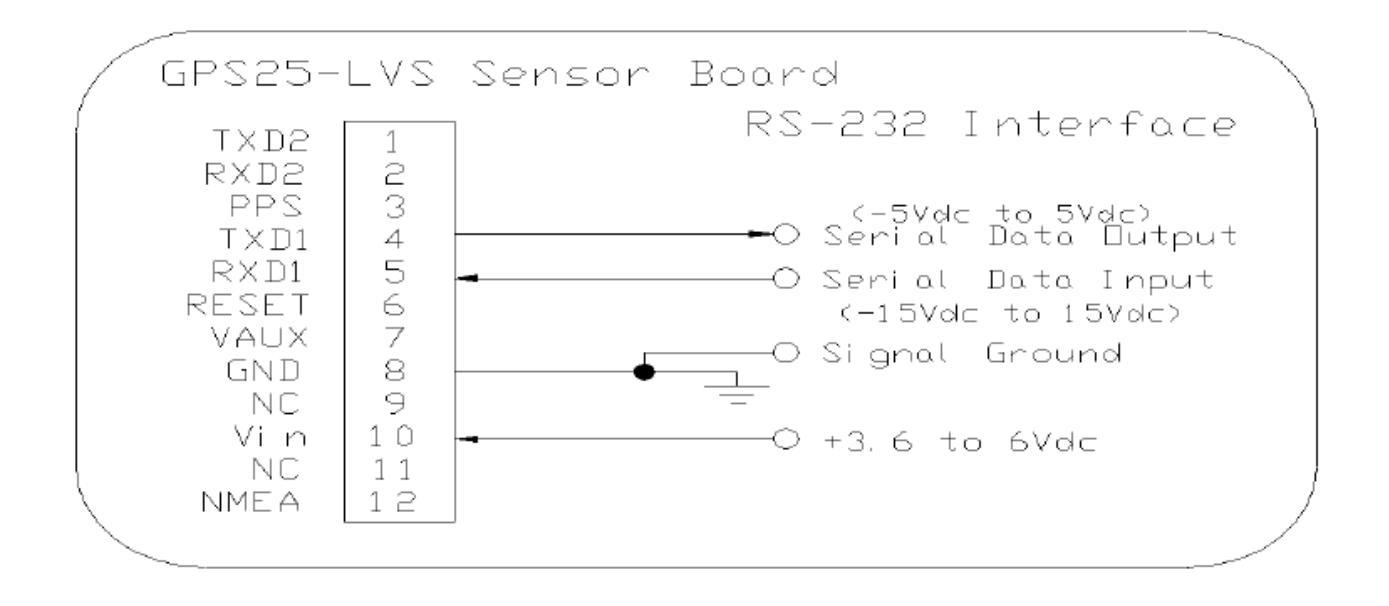
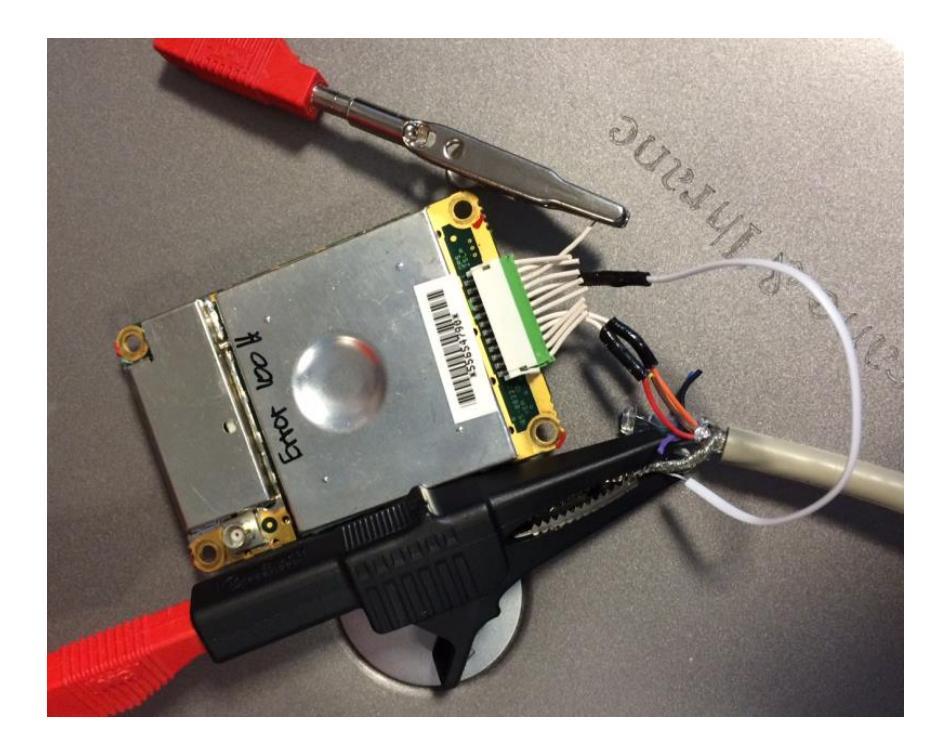
Update configuration in Garmin module:

You should connect your computer via a standard RS-232 interface to the GPS module.

You can download software version 2.50 and SNSRCFG_320 tool via the link below.

http://www8.garmin.com/support/collection.jsp?product=010-00124-00
